Tuzla – Podisor Pipeline Site Visit Report

3. Site Visit Findings

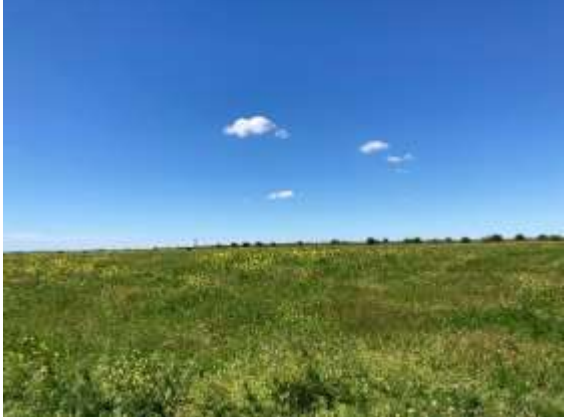
Km.	Image	Findings
0

<p>Connection point with Gas station owned by the Black Sea Gas extraction operation company:</p> <ul style="list-style-type: none"> • TG pipeline will go along the future planned access road designed for the Gas station. There is no map yet where to observe the overlaps between the two projects – the gas pipeline and the access road. • Proximity to railway station • Proximity to a temporary structure / shelter for animals / cows • Grazing area for cows • The proximity to Black Sea shore might overlap with the high interests for future development of touristic activities – this aspect should be further investigated by analyzing the local development plans and during consultation with interested parties in the sector. • Proximity to waste depositing area – illegal dumping. Several areas were observed where construction waste has been deposited. • Here there is a mosaic of man-made habitats: pasture, abandoned orchard, irrigation canal and cultivated land. • In the area there are small mammal species <i>Nanospalax leucodon</i>, <i>Talpa europaea</i>, <i>Apodemus</i> sp. and <i>Mus</i> sp. • The area is also part of the coastal migration corridor for birds and is a nesting place for species among <i>Paseriformes</i>.

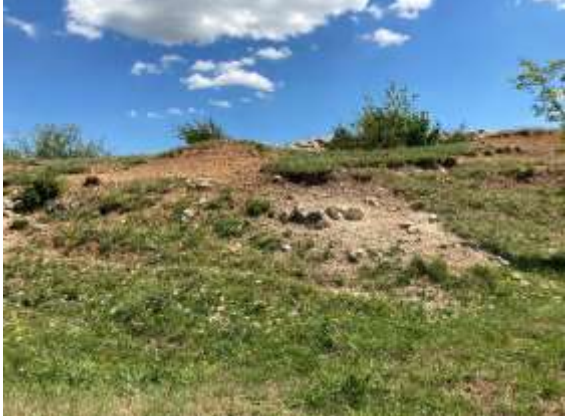
Km.	Image	Findings
63

<p>Hill area with rocky formations:</p> <ul style="list-style-type: none"> • Geological aspects - rocky formations are presents and visible, mainly lime stones • Maybe this area used to be a drill area for nearby army unit and the formations visible on google earth are just wholes in the ground made by the fires • Further investigations are needed in order to understand / confirm if the military unit used this area for such drills and if there is any chance to find unexploded materials • located in a habitat mosaic area and crosses the pontosarmatic steppe (priority habitat) and pontosarmatic bushes (priority habitat) • In the area it is recommended to monitor the activity of small mammals, even on the route of the pipeline being identified a group lair of Spermophilus citellus, and in the immediate vicinity signs of the presence of the species Nanospalax leucodon • the specific vegetation of the ponto-sarmatic steppe may have protected flora elements: Moehringia jankae (in the area of calcareous outcrops), Echium russicum (plant with biannual cycle requires monitoring 2 consecutive flowering seasons to confirm / deny presence) or Hymantoglossum caprinum (orchid). • Wind farm located in the proximity – further investigations are needed in order to understand the development plans for expansion of the farm if the case • Once the pipeline reaches the bottom of the hill, the route enters in a valley that is sometimes a flooding area for a small water stream that is a tributary to Danube – further hydrological and meteorological data should be analysed in order to understand the flooding risks

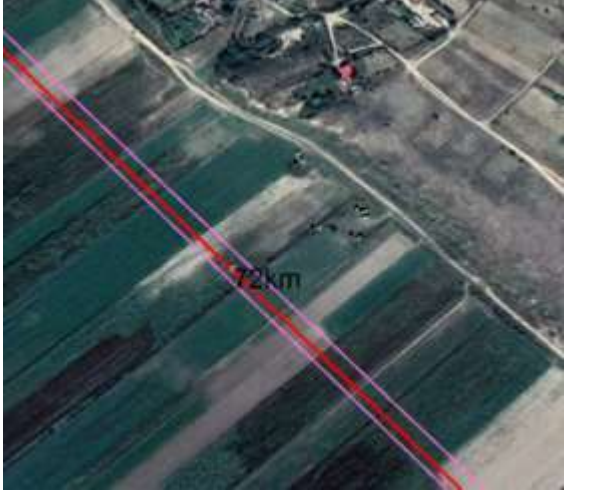
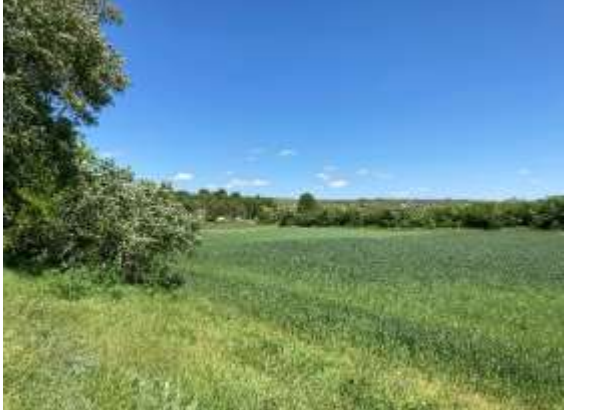
74

<p>Danube crossing – right bank of the river – HDD entry point:</p> <ul style="list-style-type: none"> • HDD work area is located on agricultural lands nearby a village – approximately 250 m away from nearby households • No access road to HDD work site • HDD site is outside the protected area, the most important biodiversity issue is the population of amphibians that can be affected by impact with work vehicles and by artificial traps formed during the works. • Access roads used for transportation of equipment and machinery necessary for HDD is not yet decided, but the national road crossing the village nearby is in good condition

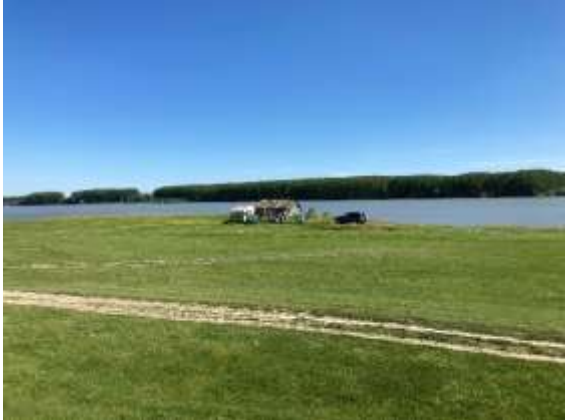
Km.	Image	Findings
93

<p>Borcea – exit point of HDD that will be used under the Borcea branch of Danube (second HDD on Danube):</p> <ul style="list-style-type: none"> • HDD site will be located on flooding area of Danube • Pasture area • Natural protected area, the area is dominated by pastures where individual actives of <i>Spermophilus citellus</i> have been observed. The area is also certainly important for amphibian populations during the rainy periods of the transition seasons (spring and autumn). Careful monitoring of these groups is recommended, including during the works. • The structure – temporary household – is situated within the construction corridor, right next to the river. The HDD exit point will be located approximate 150 m away from this point. Further investigations are needed in order to understand if the structure will be affected by the HDD work. • The area located in the vicinity of the HDD site on the Danube shore is used for leisure • Animal grazing on the pasture area

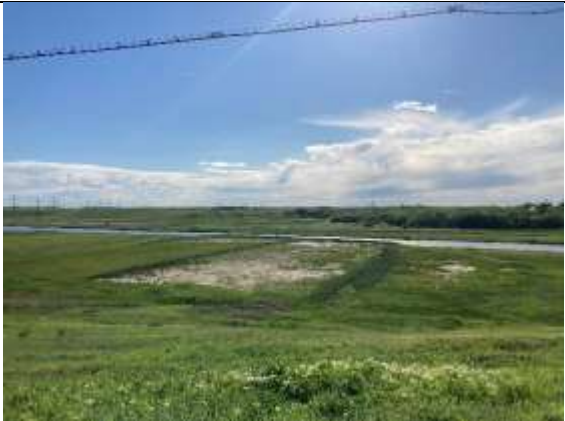
175 - 176

<p>Mostistei valley:</p> <ul style="list-style-type: none"> • A farm is located close by km. 175 • The crossing is situated close to Frasinetei village. • The area is used by recreational fishermen • Construction corridor is situated close to an informal sport field • An animal farm is situated nearby as well • Natural protected area. The transit of the wetland with specific vegetation is recommended to be done following a careful monitoring of the presence of nesting species and the activity of reptile and amphibian species. For <i>Lutra lutra</i>, knowing the territory of a couple could stretch for several kilometers of waterfronts, cannot be a special problem. • Wetland

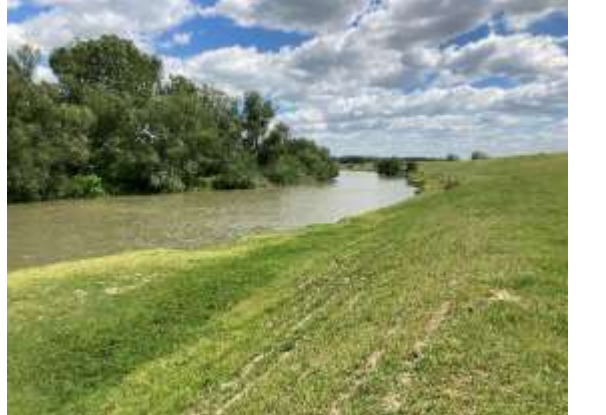
Km.	Image	Findings
201

<p>HDD crossing of the Arges river:</p> <ul style="list-style-type: none"> • HDD situated on nearby farm land • The Arges river is protected by embankments on both sides, thus reducing the flooding risk in the area • In points of this type it is recommended to monitor the avifauna activity, small mammals, reptiles and amphibians activity in the site organization area.
225

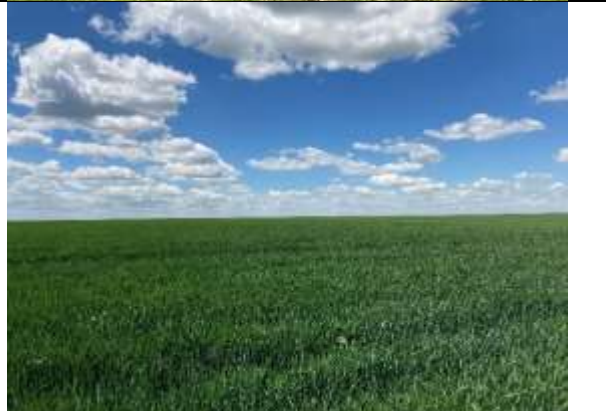
<p>Pipeline laydown area:</p> <ul style="list-style-type: none"> • Pipeline laydown area situated close to Zboiu village • The access road is an agriculture dust road • The access roads to construction corridor and the pipeline laydown areas are not yet determined • The pipeline laydown sites are already established and these areas should not suffer any modification • There are no specific issues in terms of biodiversity.

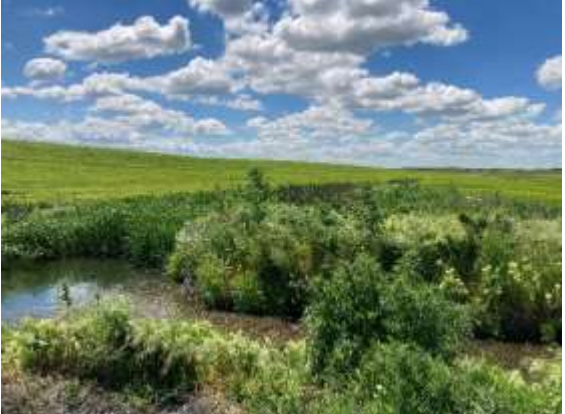
Km.	Image	Findings
228

<p>Pipeline crosses a stream part of the Comana protected area:</p> <ul style="list-style-type: none"> • Located on a tributary of the basin of the Comana ROSCI 0043 natural park. • The course is a connectivity corridor between two important sectors of the Comana Natural Park and it is important that the hydrological dynamics are not affected.
242

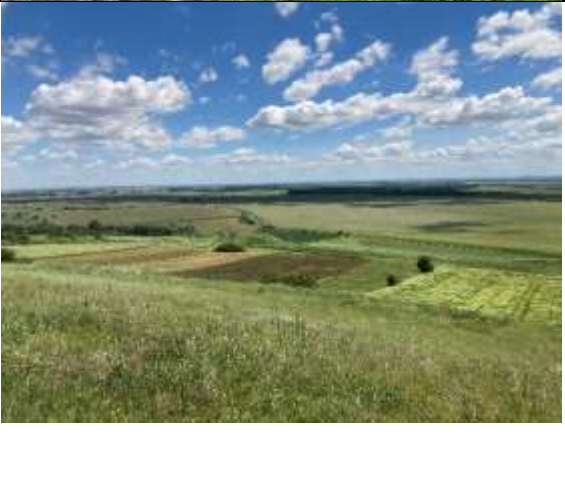
<p>Comana protected area:</p> <ul style="list-style-type: none"> • located inside ROSCI 0043 in an area of mosaic habitats: agricultural lands, pastures, watercourses, discontinuous living areas. • Vineyards are situated nearby the construction corridor and it might be that one or two land plots with vineyards might be impacted • Grazing areas for animals will be impacted • Here it is recommended an assessment of amphibian and reptile populations and continuous monitoring during the project implementation period to reduce the impact of vehicle collision, high mortality due to dehydration as a result of trapping such as pits / dry ditches from which these animals can't go out anymore. On the route of the pipeline where excavations are carried out, the presence of nests and burrows must be carefully monitored and it is recommended to avoid work in these sectors during nesting periods or for species hibernating in the soil, avoiding hibernation periods.

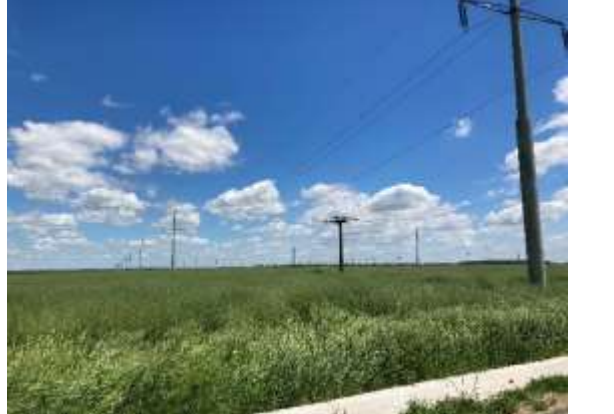
Km.	Image	Findings
248

<p>Comana protected area:</p> <ul style="list-style-type: none"> • Located at the pipe entry limit in ROSCI 0043. • The area is defined by agricultural land. The part of potentially sensitive habitats in Comana Park being crossed by horizontal drilling for the most length the potential impact is minimal. The land seems to be intensely fertilized and treated with herbicides and insecticides. • Km 248 is situated at the beginning of the protected area
295 - 296

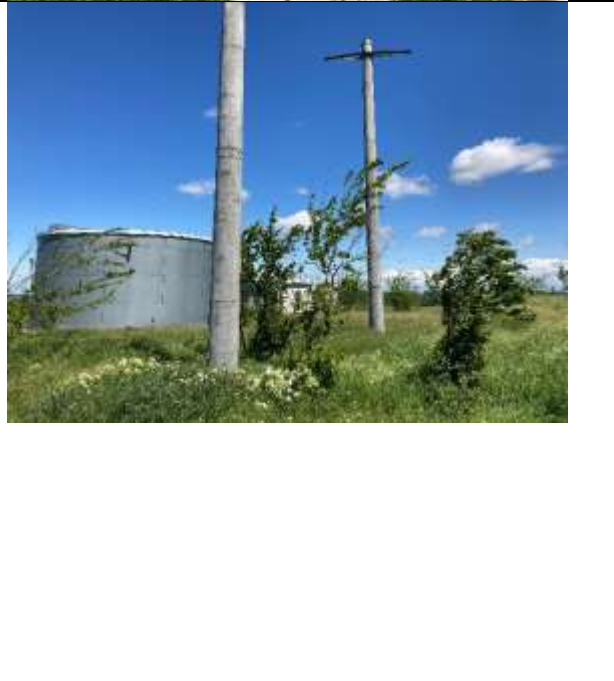
<p>Structures situated nearby the work corridor:</p> <ul style="list-style-type: none"> • located near the town of Clejani in an area of agricultural land alternating with pasture sectors with ruderalized vegetation • Between km 295 and 296 there are several oil extraction wells – further investigations are needed in order to determine the impacts associated with the oil extraction field. • Permits have been obtained from the oil extraction company and for undercrossing the oil collection pipes • Inventory of contaminated sites / areas • A structure is visible nearby km 296 – this looks like a water tank and water extraction wells but the structures are not yet finalized. It seems that the investment was made for irrigation purposes but was never finished. Further investigations are needed in order to determine the owner of these investments and the future plans since the construction corridor is very close by • There is a possibility that bird species may be present in areas of this type, especially granivores and insectivores for food. Also in the ruderal vegetation there may be active nests of passerine nests during the nesting periods.

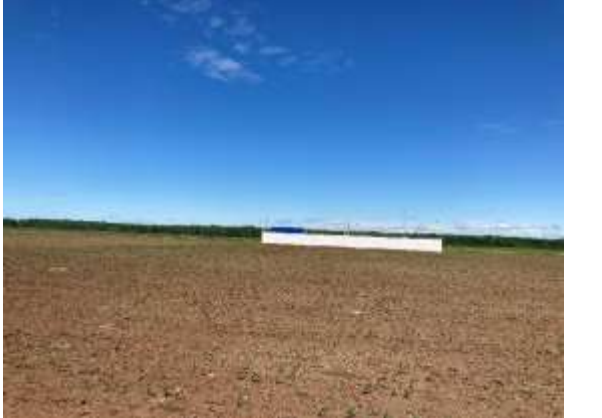
<p>Connection point to Podisor station:</p> <ul style="list-style-type: none"> • No particular aspect noticed. • The pipeline will under-cross BRUA pipeline and will access the station
